Flooding: IMPACTS ON WATER & WASTEWATER

Calgary's water treatment challenges during the 2013 flood

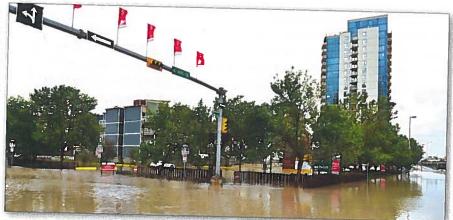
Water covered streets in evacuated downtown Calgary.
